# Manhole Inspection Summary

Manhole # S45II\_029MH

**Location** Address: **Federal St**

Cross Street: **Washington St**

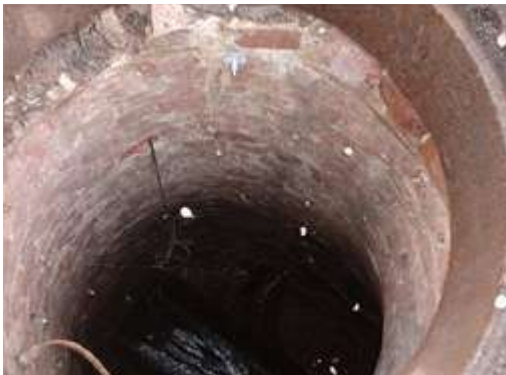
Defect 2

Condition: ☐ Sound ☐ Cracked ☐ Root Intrusion ☒ **Loose Brick** ☐ Deteriorated

deterioration

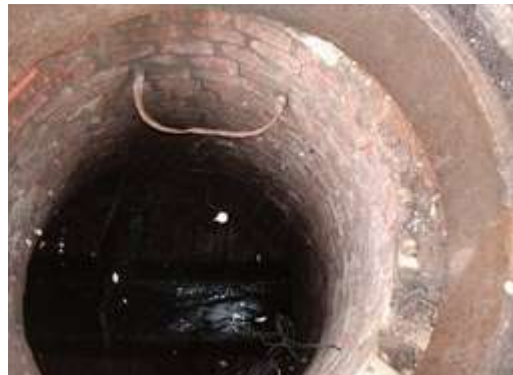
Defect 1

Infiltration: ☐ None ☐ Joint ☐ Cracks ☒ **Mortar** ☐ Roots ☐ Wall

infiltration

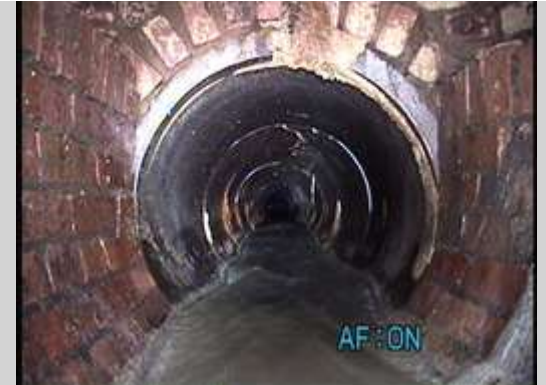
12 O'Clock Outflow

Pipe Height: **21.6** (in.) Rod and Bar (Angled)  
Pipe Material: **Clay** ☐ Pipe Lined  
Invert Depth: **12.50** (ft.) Flow Characteristics: **Fast**  
Deposits: ☒ None ☐ Mud ☐ Sludge ☐ Debris ☐ Grease  
Silt Depth: (in.) Deposits Extent:  
Infiltration: **None** Pipe Seal Cond: **Sound**

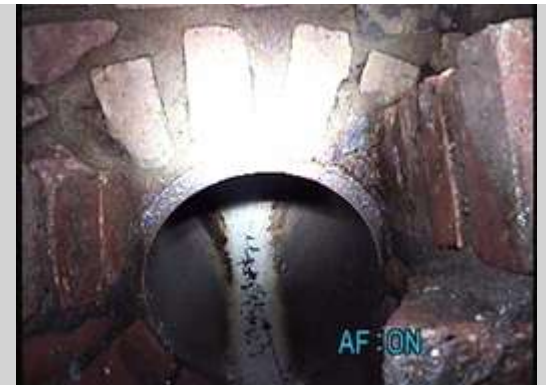
3 O'Clock Inflow

Pipe Height: **8.4** (in.) Rod and Bar (Angled)  
Pipe Material: **Clay** ☐ Pipe Lined  
Invert Depth: **11.30** (ft.) Flow Characteristics: **Fast**  
Deposits: ☒ None ☐ Mud ☐ Sludge ☐ Debris ☐ Grease  
Silt Depth: (in.) Deposits Extent:  
Infiltration: **None** Pipe Seal Cond: **Sound**

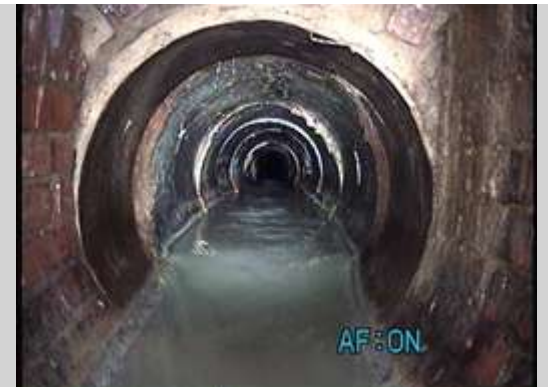
6 O'Clock Inflow

Pipe Height: **21.6** (in.) Rod and Bar (Angled)

Infiltration: **None** Pipe Seal Cond: **Sound**

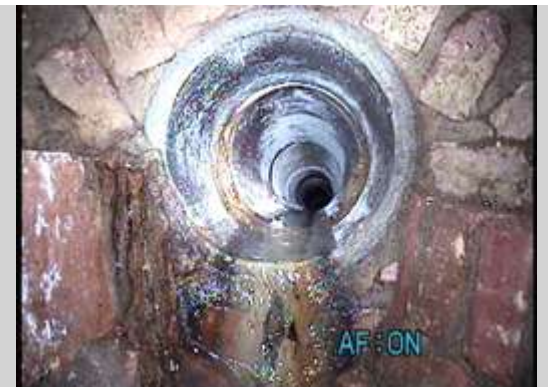
9 O'Clock Inflow

Pipe Height: **8.4** (in.) Rod and Bar (Angled)

Invert Depth: **10.50** (ft.) Flow Characteristics: **Slow**

Infiltration: **None** Pipe Seal Cond: **Sound**

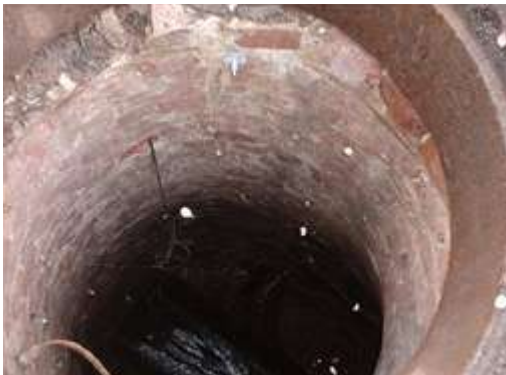
Defect 2

Condition: ☐ Sound ☐ Cracked ☐ Root Intrusion ☒ **Loose Brick** ☐ Deteriorated

deterioration

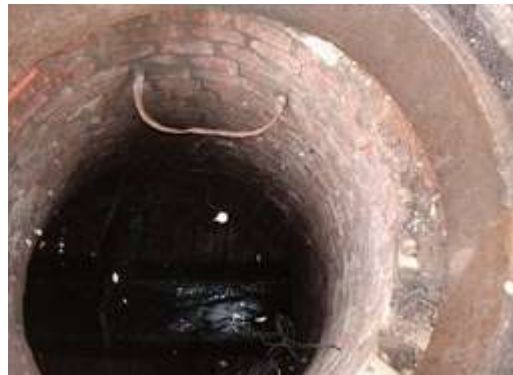
Defect 1

Infiltration: ☐ None ☐ Joint ☐ Cracks ☒ **Mortar** ☐ Roots ☐ Wall

infiltration

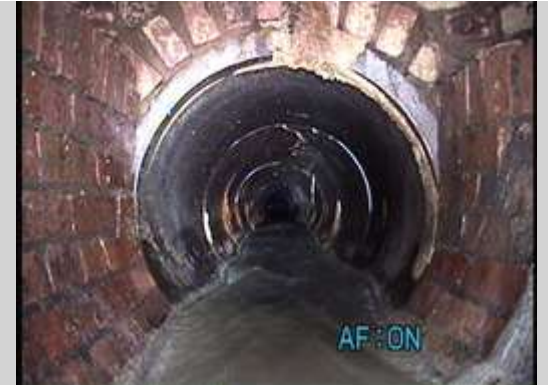
12 O'Clock Outflow

Pipe Height: **21.6** (in.) Rod and Bar (Angled)  
Pipe Material: **Clay** ☐ Pipe Lined  
Invert Depth: **12.50** (ft.) Flow Characteristics: **Fast**  
Deposits: ☒ None ☐ Mud ☐ Sludge ☐ Debris ☐ Grease  
Silt Depth: (in.) Deposits Extent:  
Infiltration: **None** Pipe Seal Cond: **Sound**

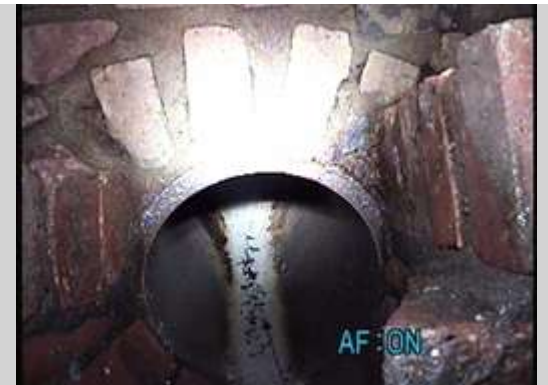
3 O'Clock Inflow

Pipe Height: **8.4** (in.) Rod and Bar (Angled)  
Pipe Material: **Clay** ☐ Pipe Lined  
Invert Depth: **11.30** (ft.) Flow Characteristics: **Fast**  
Deposits: ☒ None ☐ Mud ☐ Sludge ☐ Debris ☐ Grease  
Silt Depth: (in.) Deposits Extent:  
Infiltration: **None** Pipe Seal Cond: **Sound**

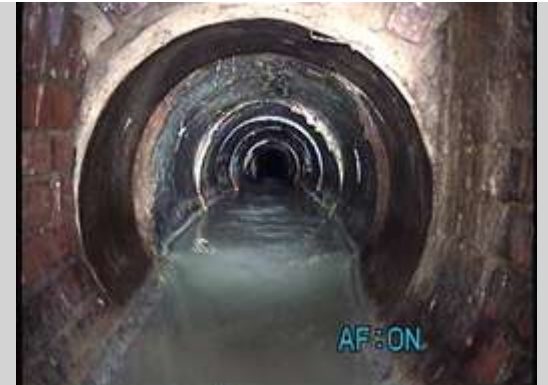
6 O'Clock Inflow

Pipe Height: **21.6** (in.) Rod and Bar (Angled)

Infiltration: **None** Pipe Seal Cond: **Sound**

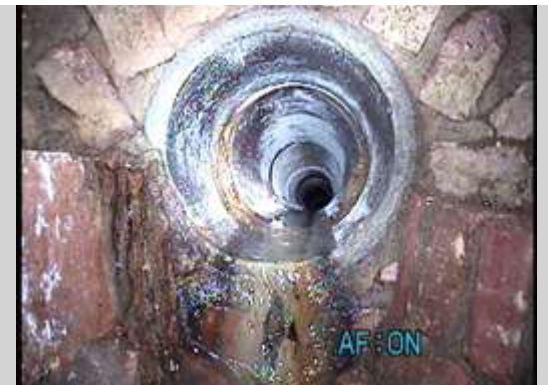
9 O'Clock Inflow

Pipe Height: **8.4** (in.) Rod and Bar (Angled)

Invert Depth: **10.50** (ft.) Flow Characteristics: **Slow**

Infiltration: **None** Pipe Seal Cond: **Sound**
